[BOND BEAM HEAT TRANSFER]

Written by, Dale W. Feb

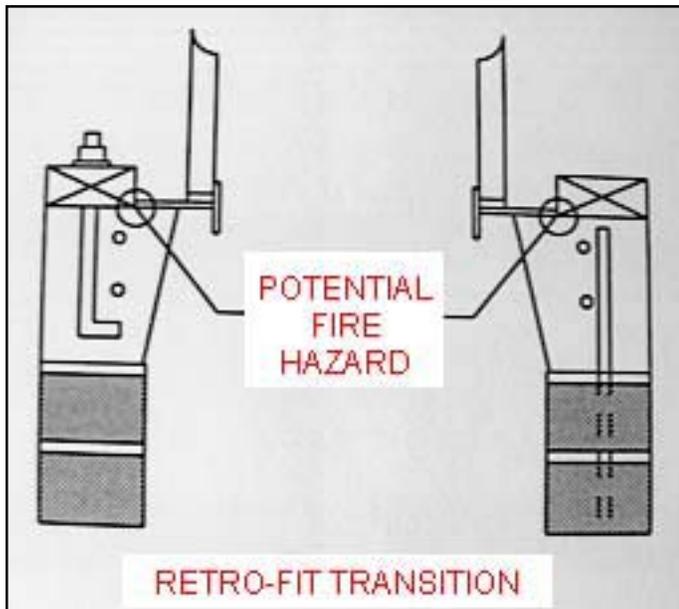
Subsequent to the Northridge Earthquake in 1994, the City of Los Angeles provided an emergency fire-place repair detail. This detail inadvertently allowed the use of pressure treated wood in direct contact with the top of a newly constructed concrete bond beam. Unfortunately this detail was rapidly adopted by many surrounding Jurisdictions.

The problem is located at the contact point between the wood sill plate and the newly constructed bond beam. Attempting to build the framed chimney shaft the same width and depth as the existing masonry

chimney produces a very small bond beam. In many instances the bond beam is so small that the bottom wood plate is trimmed in order to meet the clearance requirements of the listed metal chimney pipe. Under most conditions the thickness of the bond beam that the heat is to travel through may be as thin as two inches. This condition will allow the heat to transfer through the bond beam to the wood sill plate. In time, pyrolysis to the wood may occur, and eventually fire, therefore defeating the purpose of the clearance requirements.

The requirement for a steel "only" chimney shaft would eliminate this potential fire hazard.
